## A Survey of Thatched Buildings in Scotland

Thatch Survey of Scotland  
2014-15

A photographic survey of thatched buildings in Scotland, surveyed between May 2014 and August 2015 by Zoe Herbert (SPAB Scotland Officer), on behalf of the Society for the Protection of Ancient Buildings.

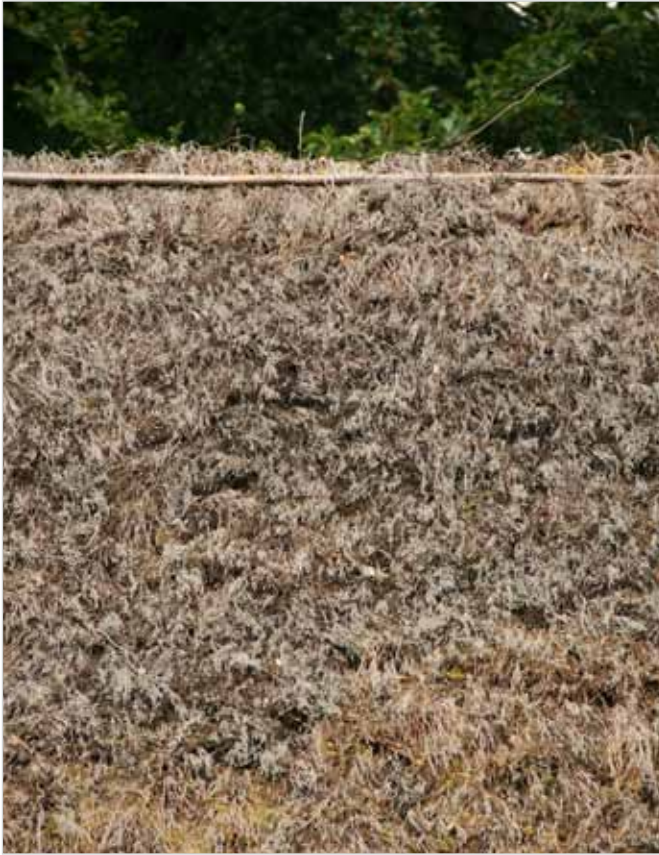
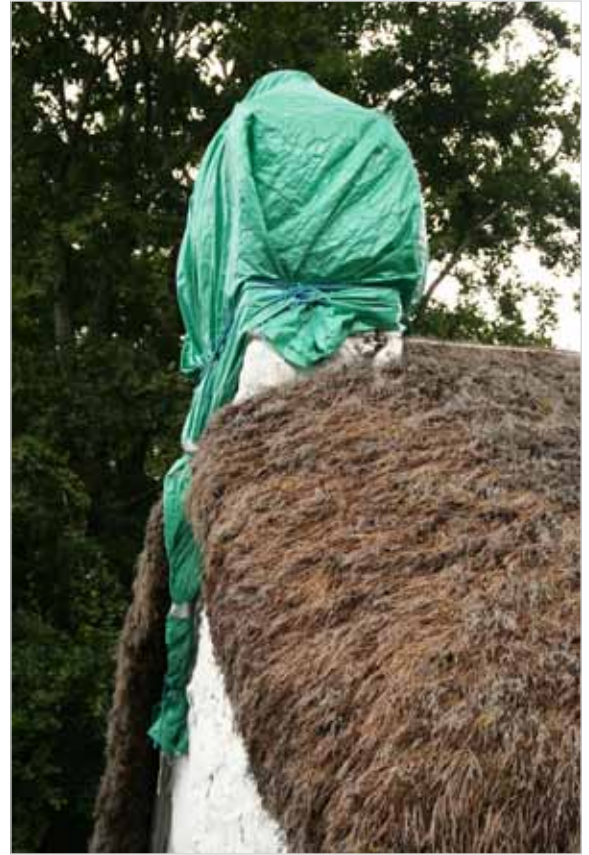
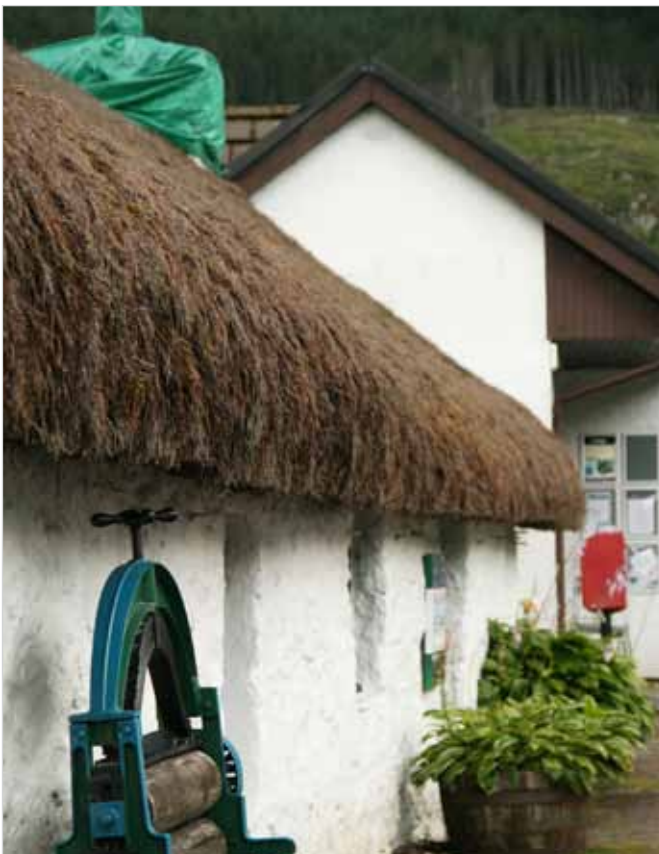
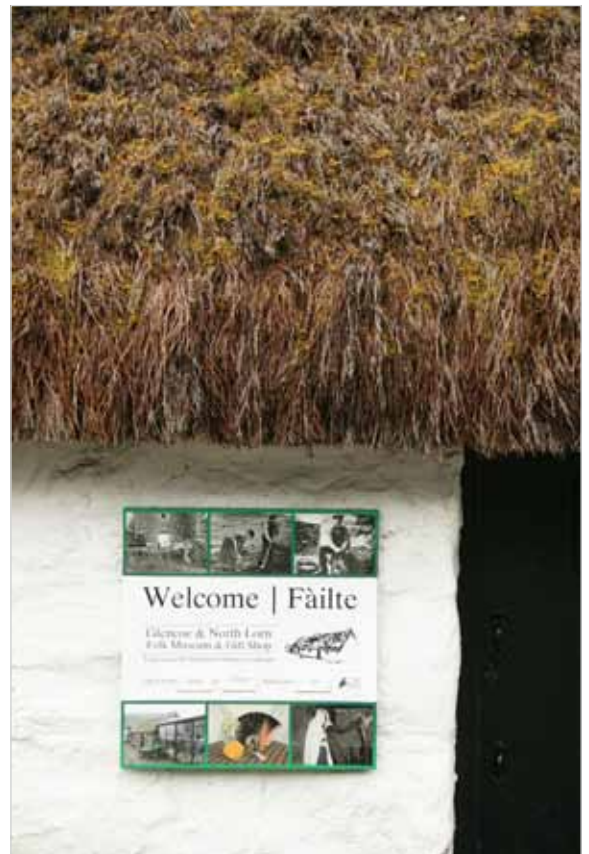
Glencoe and North Lorne Folk Museum – Highlands

Condition of Thatch: Good

**Additional Notes:** Earlier-mid 19th-century pair of adjoining single-storey cottages, currently in use as part of the Glencoe and North Lorn Museum. An excerpt of text on Canmore states that the cottages were last lived in until the 1950s, and '*restored from dereliction, re-thatched with heather and converted to a museum*' in 1971 (Miers, M. (2008), *The Western Seaboard: an illustrated architectural guide*, Edinburgh). Whilst the cottages are listed as being '*earlier-mid 19th century*', the text on Canmore states that the cottages date from circa 1700. The roof of the building is thatched in heather, which has been left uncovered, and has a continuous heather ridge.

The top layer of thatch along the ridge has been secured with a single row of metal wire, which has been covered with a row of thin wooden branches. There is a small amount of mossy vegetation growth across the surface of the thatch in places. According to the museum's website, the last re-thatching of the roof was completed in January 2014.

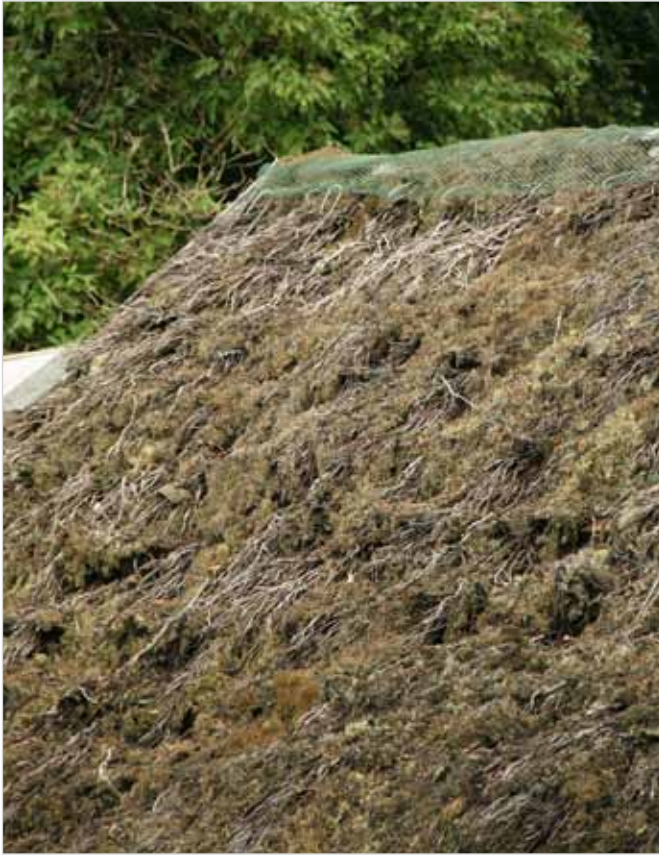
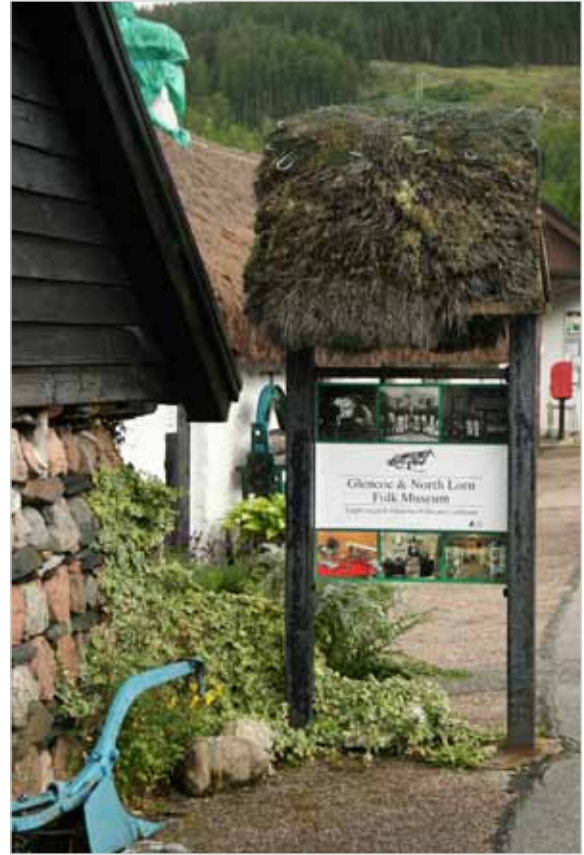
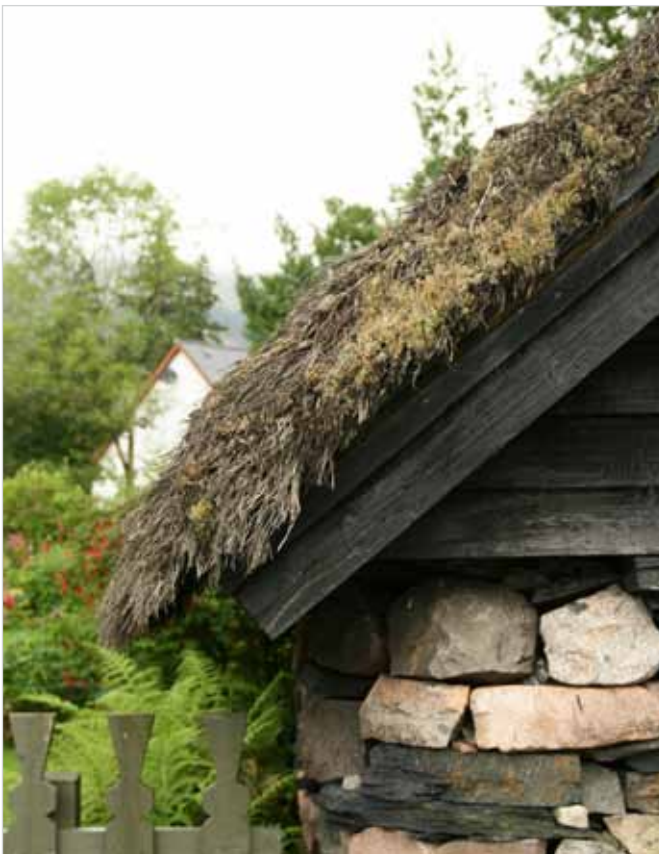
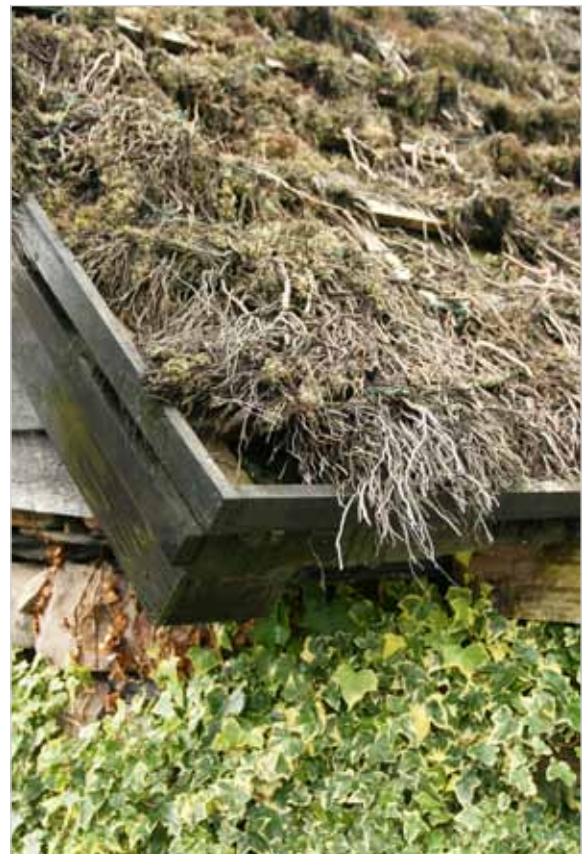
Massacre Room – Highlands

Condition of Thatch: ..... Poor

**Additional Notes:** The building is part of a group listing with the adjacent cottage, both of which form the Glencoe & North Lorn Museum. The byre is contemporary to the cottages, but is of unknown date. The roof is thatched in heather and has a continuous heather ridge. It has been left uncovered except for along the ridge, which has been covered in a strip of netting that is secured to the roof by metal pegs. Much of the heather is missing throughout the thatch, which is exposing the roof structure beneath, and there is an amount of mossy vegetation growth across the surface of the heather. Next to the byre is a street sign that has a pitched heather-thatched roof.

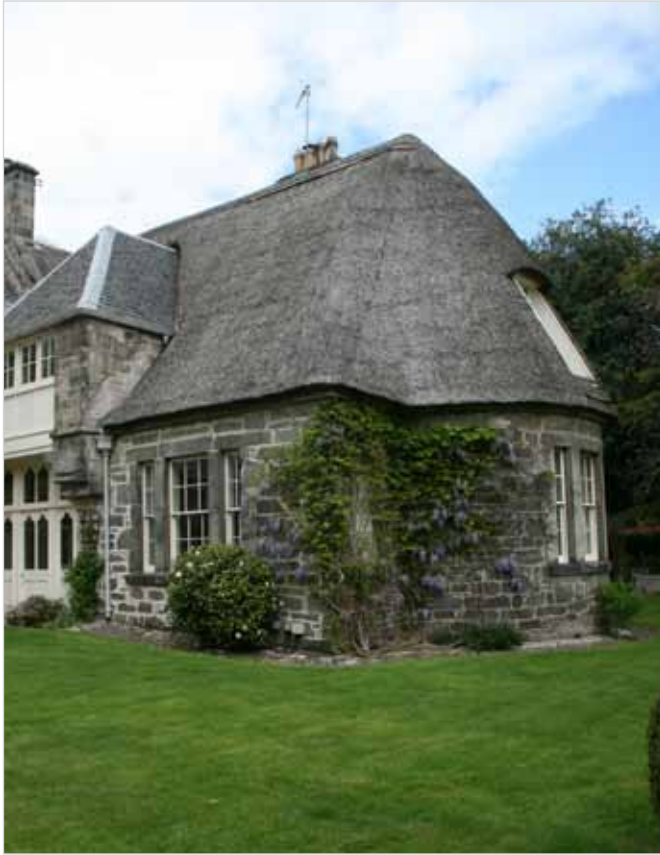
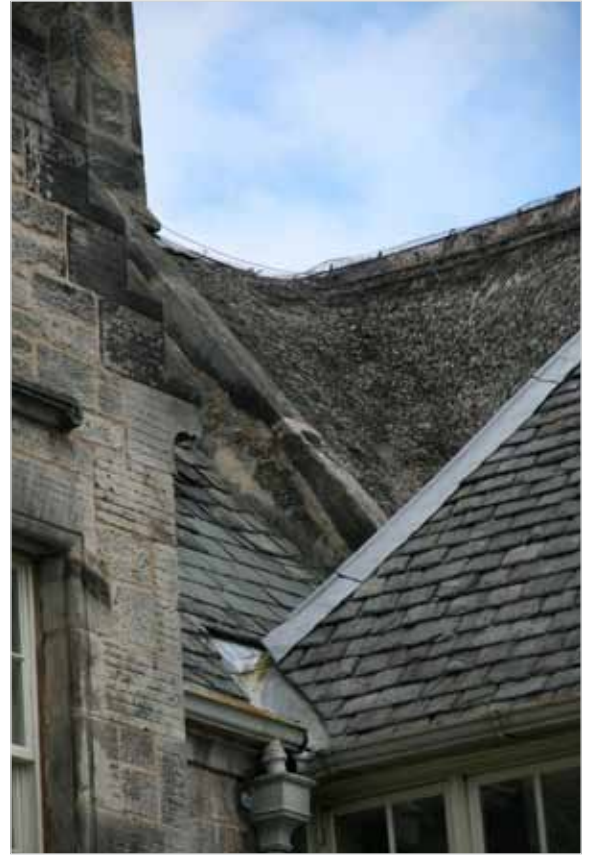
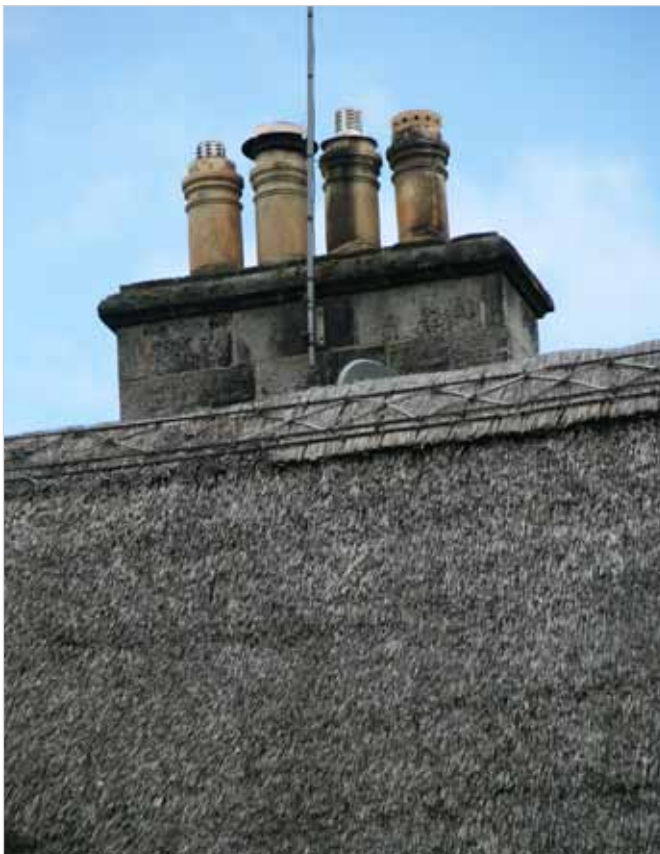
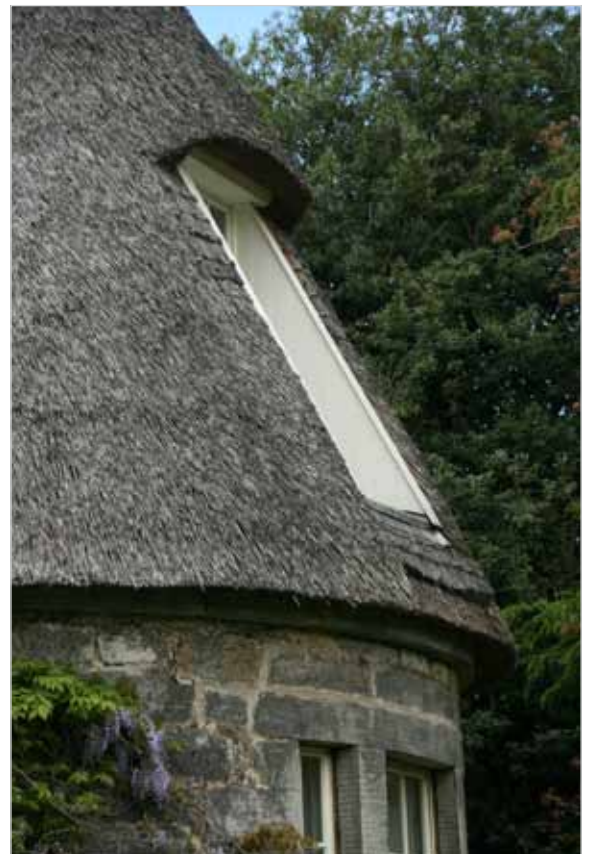
Barony House – Midlothian

Condition of Thatch: ..... Good

**Additional Notes:** ..... Circa 1781 L-plan thatched extension to earlier 18th-century cottage. The wing located at the east of the building is currently thatched in reed and was last re-thatched approximately 12 years ago (around 2002). The thatch is netted in some places, and the thatched ridge, which is scobed with hazel spars and fixed with metal rods and wire horizontally, is entirely netted. The ridge has deteriorated slightly since it was last thatched, sagging away from the netting in places. To the south, the wing has a rounded hip with a central recessed dormer window just above the eaves, which has scobed detailing directly below the window and underneath the sculpted thatched hood at the dormer cheeks.

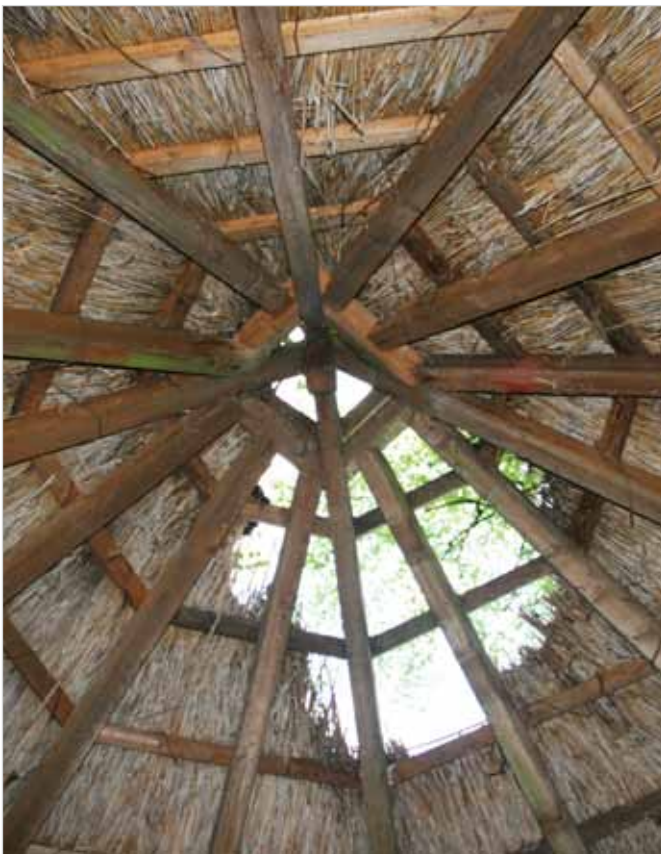
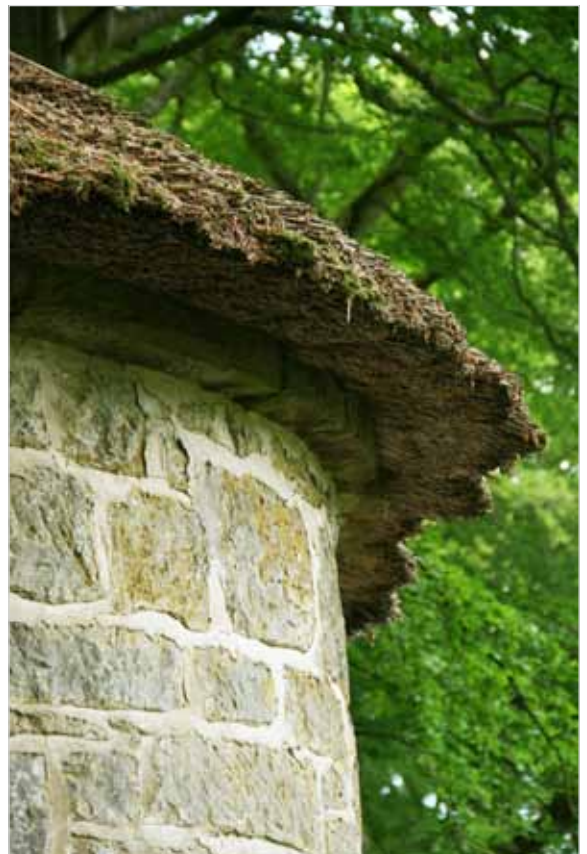
Rustick Hut – Midlothian

Condition of Thatch: ..... Poor

**Additional Notes:** ..... Late 18th-century circular ashlar stone structure with conical thatched roof. There are pointed arch openings and a pointed window that overlooks the North Esk river to the south. The roof appears fairly sound when viewed externally however upon entering the structure a large opening is visible in the thatch above, exposing the interior of the building to the elements. The remaining thatch is in a reasonable condition, with some mossy vegetation growing throughout across the surface of the thatch. The timber elements of the roof, and the building in general, are currently in a stable condition, but the roof is likely to deteriorate if it is not repaired

soon. Although listed as being an 'outbuilding', the structure currently has no apparent use. The thatch is not netted.

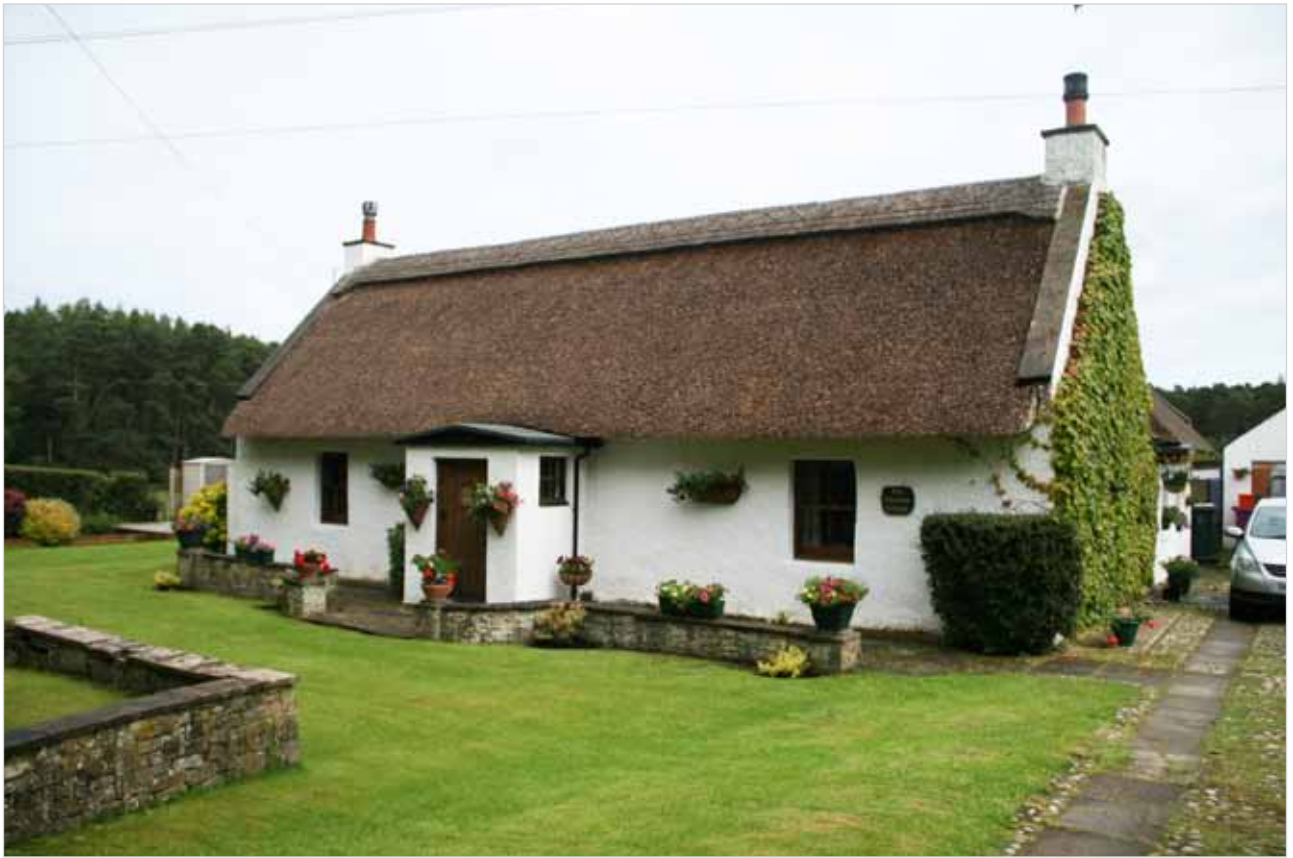
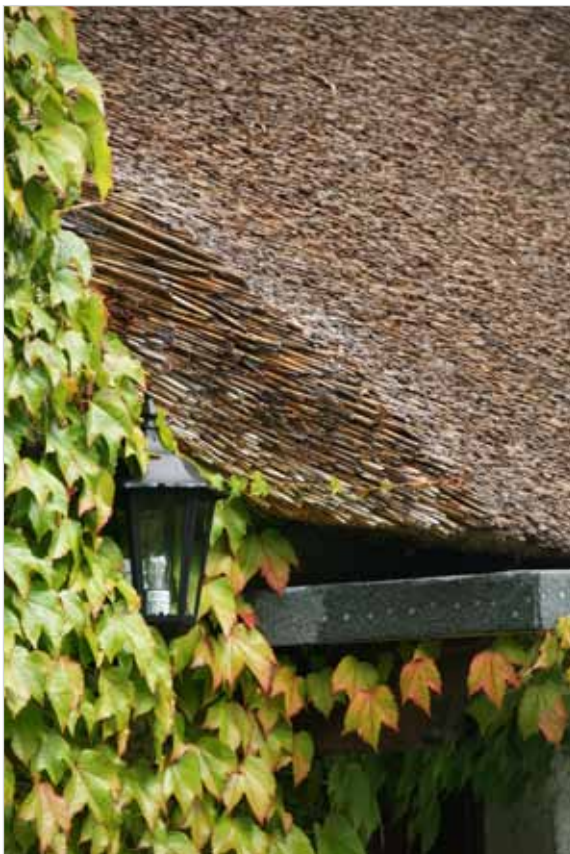
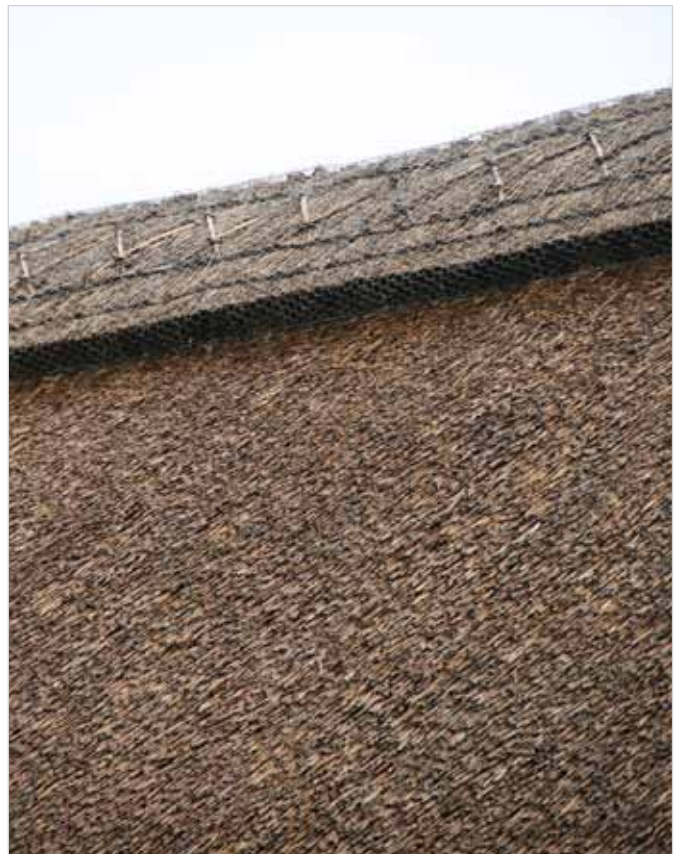
Loch Na Bo Croft – Moray

Condition of Thatch: ..... Good

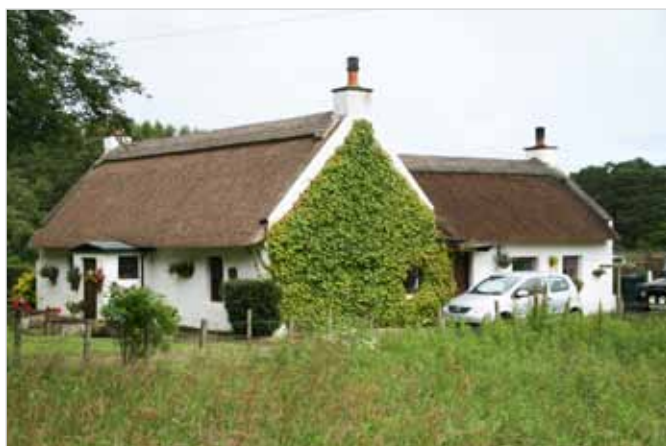
**Additional Notes:** ..... Listed building description reads '*Early/mid 19th century. Single storey 3-bay cottage with wing to rear forming L plan*', with the listed building description notes stating it was thatched by 'John Brockie circa 1970'. According to the owners the building was last re-thatched two years ago (2012) in reed by a thatcher from Castle Douglas. The raised thatched ridge is scobed with hazel spars and is also netted, whilst the rest of the thatch is uncovered. The building has concrete skew copes that partially overlap onto the thatch. The thatch overhangs deeply at the eaves and is sculpted slightly to allow room for the roof of the entrance porch.

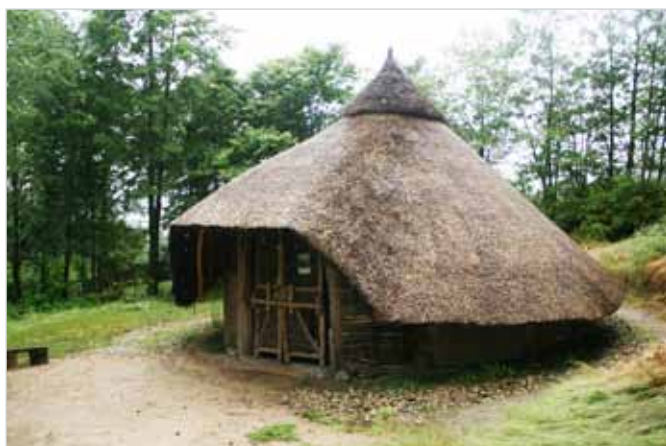
Bronze Age Replica Roundhouse – North Ayrshire

Condition of Thatch: ..... Good

to the roof structure using what appears to be

natural ropes or bracken.

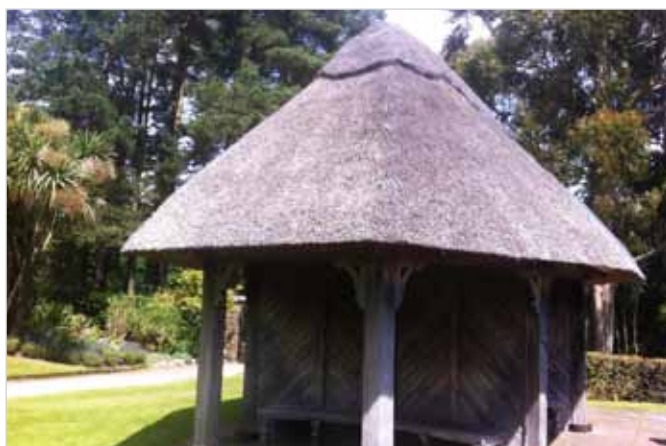
Brodick Castle Summerhouse – North Ayrshire

Condition of Thatch: ..... Good

Additional Notes: ..... Modern thatched timber summerhouse in the grounds of Brodick Castle, a National Trust for Scotland property open to the public. The roof is thatched in reed and has a raised heather-thatched ridge. The thatch is entirely netted including across the ridge. The summerhouse was re-thatched in 2012 at the same time the Bronze Age Replica Round House (Survey Number 138) was built while thatcher Jeremy Cox was on site.

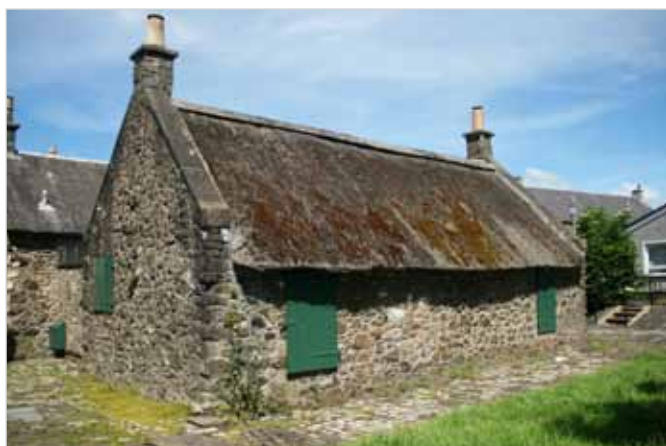
The Heckling Shop – North Ayrshire

Condition of Thatch: ..... Poor

used as a museum in 2010. The thatch is fairly decayed in places and there is a large amount of vegetation growth

throughout. There is also a large amount of loose reed, particularly on the west pitch of the roof. There are

cement fillets between the thatch and the skewers. The thatch is netted all over and held in place with metal pegs.

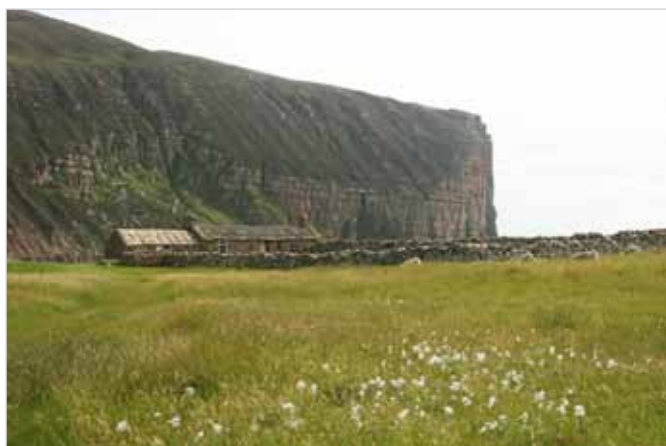
Burnmouth Hostel – Orkney Islands

Condition of Thatch: ..... Good

The bothy has a heather-thatched roof, with a continuous heather ridge. The thatch is netted and weighted with stones along the ridge, in a row along the centre of the thatch and secured to the eaves. There is a small amount of mossy vegetation growth across the surface of the thatch. Both the main building and the NE projection, which has a flagstone roof, are open publicly as a bothy. The notes of the listing description reads '*this long low building displays two important and traditional roof types peculiar to Orkney. The main block is heather thatched; the roof*

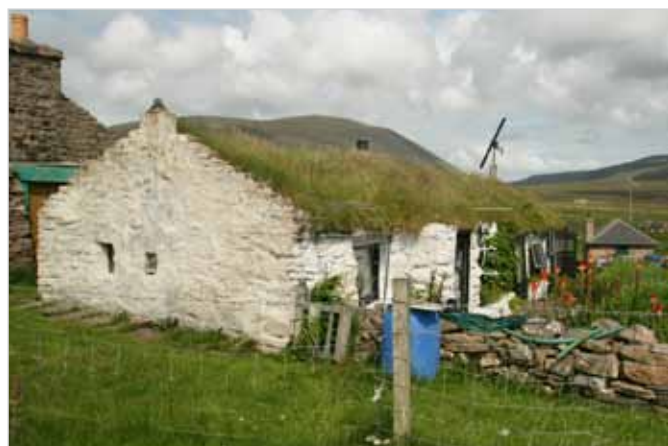
Muckle House – Orkney Islands

Condition of Thatch: ..... Good

Additional Notes: ..... Late 19th-century single-storey cottage with a turf-thatched roof and a central ridge chimney stack. The turf thatch is flourishing and has a number of different grasses and flowers growing in it. Turf is a traditional roofing technique in Orkney and this is one of only a few examples left on the islands.

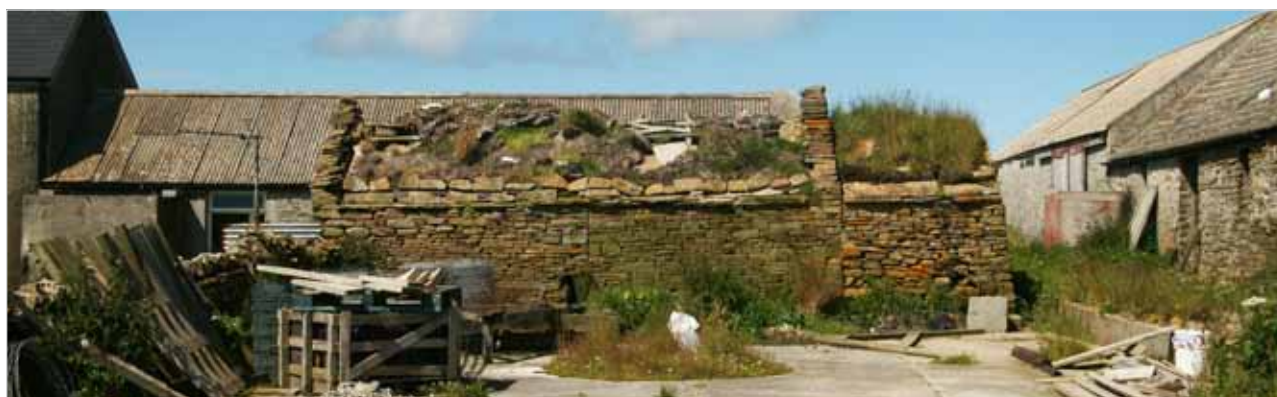
Address: ..... Boloquoy Farm

**Additional Notes:** ..... Early to mid 19th-century farm complex, listed as a group. The farm cottages to the east of the main farmhouse, the detached byre to the east and the parallel byre to the west are all listed as having thatched roofs (some with turf and some with straw). The only visible evidence of any thatch at the site is on the 'parallel byre' (pictured below). It is described in the listing description as having a 'turf thatched roof to left, straw thatch to right, secured at eaves with bendlin stanes'. In fact the roof to the west is thatched in straw, and that to the east is thatched in turf. Both roofs of this building are in a poor condition and there are many holes in the thatch exposing the interior of the building, as well as a large amount of vegetation growth throughout. There is visible evidence of netting as well as small stone slabs used along the eaves to secure the netting. You can also see some of the flagstone slabs that were placed underneath the thatch, a tradition on Orkney. The listing description for this building should be updated accordingly.

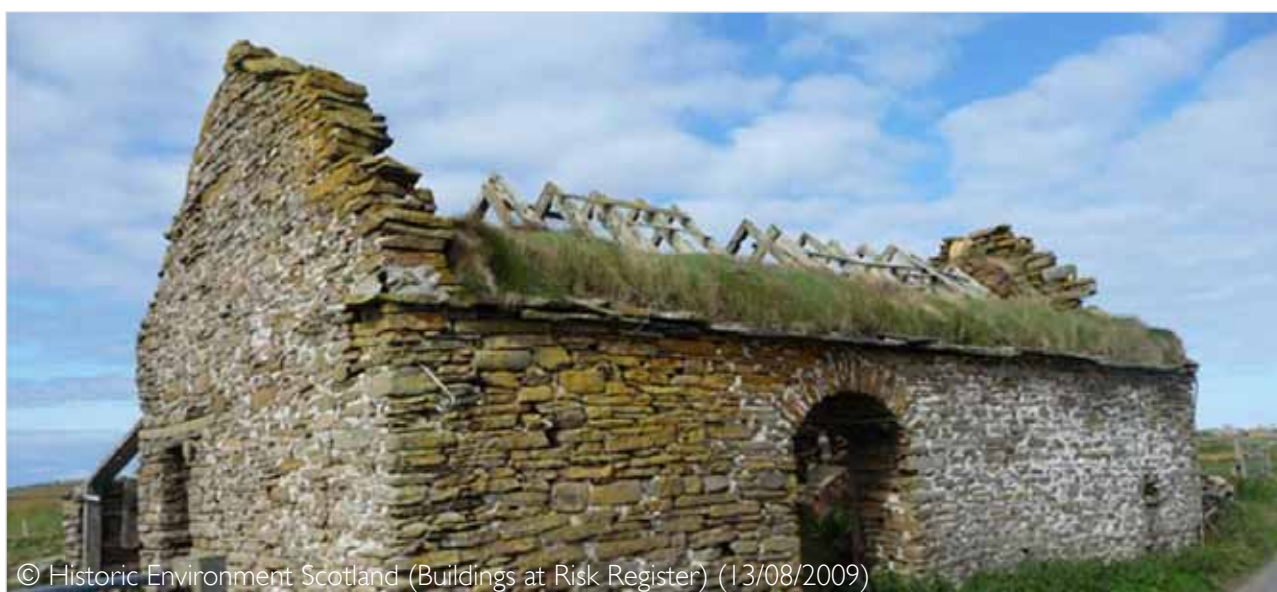
Address: ..... Hooking Watermill

**Additional Notes:** ..... Early 19th-century watermill, listed in 1999 as having '*remnants of flagstone and turf-thatched roof*'. It was placed on the Buildings at Risk (BAR) Register in 2009 (BAR reference number 4131), at which time it was noted by BAR to be in a ruinous condition. In 2011, the status of the building on the BAR register was changed to '*Restoration in Progress*'. A phone call was made in July 2015 to the planning department in Orkney Islands Council where it was reported that the building had been restored and confirmed the building was no longer thatched. It was stated that the watermill now has a flagstone roof, also a traditional roofing technique in Orkney. No site visit was made. The listing description for the building should be updated accordingly.

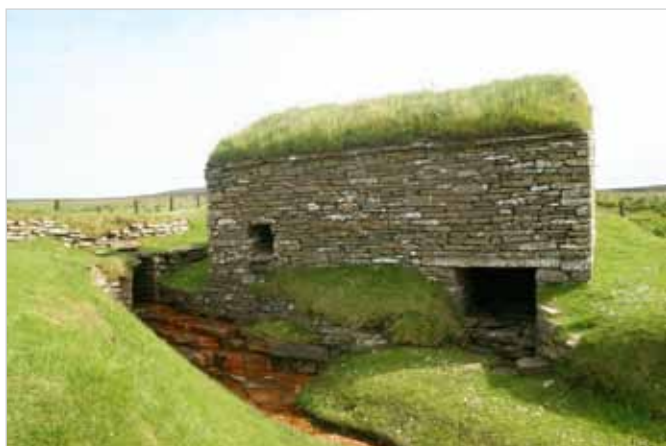
The Click Mill – Orkney Islands

Condition of Thatch: ..... Good

**Additional Notes:** ..... Circa 1825 small oblong mill; according to the listing notes it is the 'last surviving working example in Orkney of a primitive type of mill more numerous represented in Shetland and Faroes'. The building has a flagstone roof covered with turf a traditional roofing technique in Orkney, which is thatched continuously across the ridge. The thatch has been left uncovered. The mill, which is in working condition, is open to the public and is in the guardianship of Historic Environment Scotland.

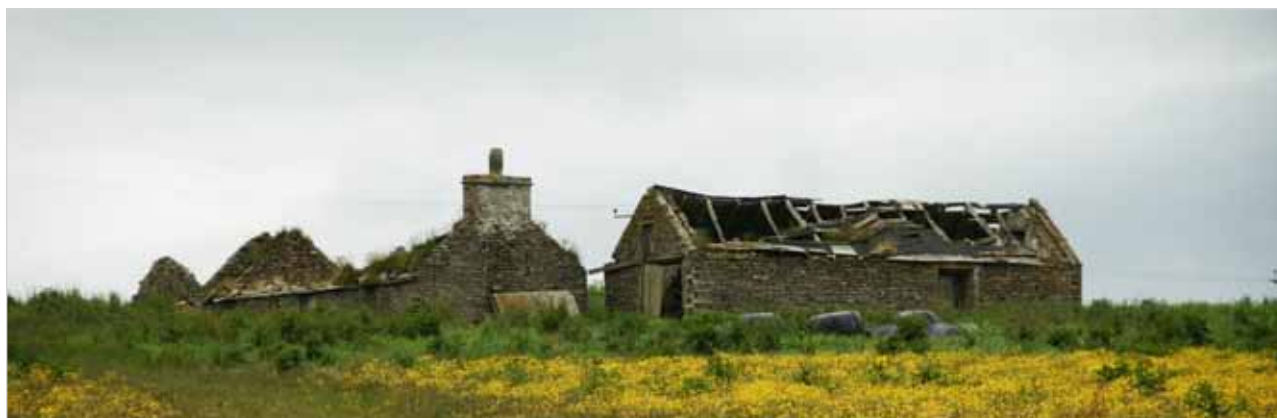
Address: ..... Toab Cottage and Store

**Additional Notes:** ..... Mid 19th-century cottage and byre/store buildings in L-plan group. Listed in 1999, the south store is listed as having a 'turf roof with individual anchor stones', whilst the cottage/bothy is listed as having a 'fine needled roof with turf covering' and 'individual anchor stones at eaves'. There is also an extensive description of the roof of the cottage/bothy in the notes section of the listing description, explaining how it is 'one of the best surviving examples of the traditional Orkney roofing technique'. The cottage has been on the Buildings at Risk (BAR) Register since 2004 (BAR reference number 2641), at which time it was recorded that the thatch was deteriorating and the building was derelict. In 2013, BAR had recorded that the thatched roof had '*almost completely collapsed*'. The roof of the cottage, and of the previously thatched store building, has collapsed and no thatch remains intact. The store to the north, listed as having a corrugated iron roof, is also derelict and much of the roof has collapsed. The listing description should be updated accordingly.

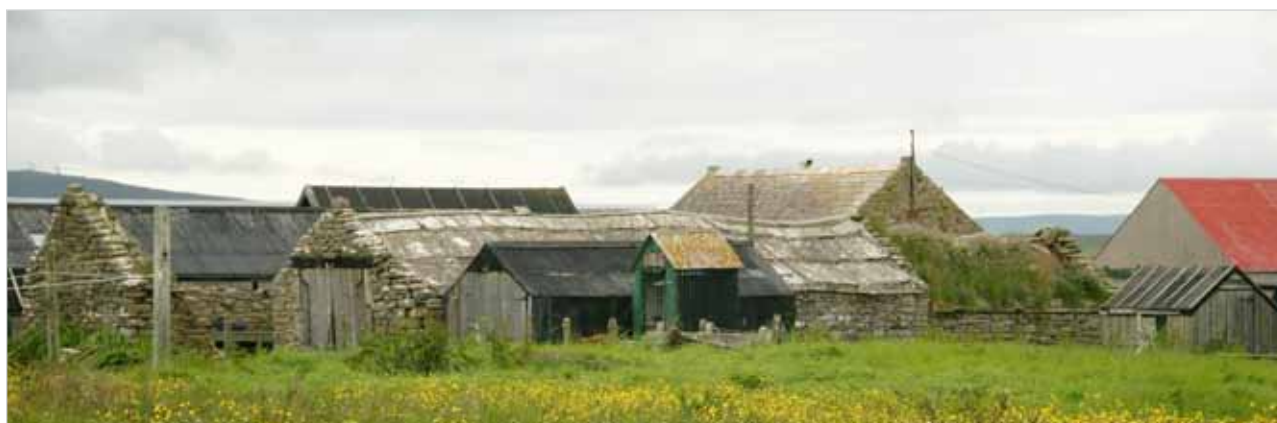
Address: ..... Scarpigar Farm Buildings

**Additional Notes:** ..... The longhouse range, bothy and barn/byre range, which form part of this group listing of mid 19th-century farm buildings, are listed as having a mixture of turf and straw-thatched roofs, some also with flagstones. The longhouse range, seen in the foreground of the image below (behind the black barn), has a flagstone roof to the south (left) and the remains of a thatched roof to the north (right). The condition of the thatch is uncertain due to the large amount of vegetation growth, however the building appears to be derelict and there are large openings in the roof exposing the interior of the building. There is visible evidence of netting still intact. Whilst only part of the byre range could be seen upon visiting, which was roofless, the Buildings at Risk (BAR) Register would confirm that the building is a roofless ruin and that no thatch remains. The longhouse range has been on the BAR Register since 2009 (BAR reference number 4149), as has the barn/byre range (BAR reference number 4150). The bothy now has a flagstone roof.

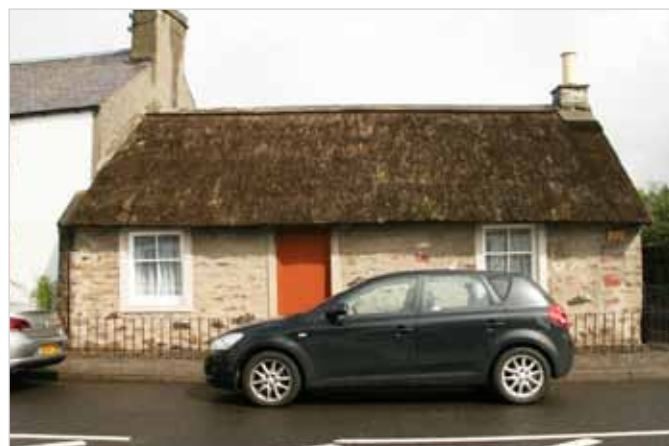
Hawthorne Cottage – Perth & Kinross

Condition of Thatch: ..... Good

..... has a concrete ridge The thatch has been left uncovered and has been boxed in at the skewes on the east gable.

..... There is a small amount of mossy vegetation growth across the surface of the thatch.

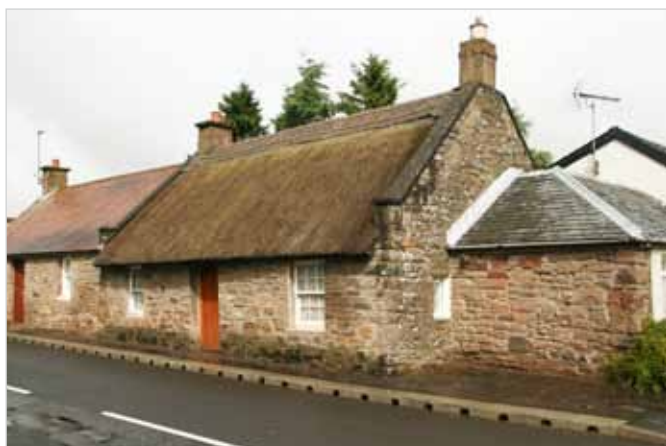
The Quoins Cottage – Perth & Kinross

Condition of Thatch: ..... Good

**Additional Notes:** Part of a group listing of two 18th-century semi-detached cottages. The west cottage (Steeple Cottage) has a red tile roof, whilst the east cottage is listed as having, and retains, a thatched roof. The roof has a reed-thatched ridge, which has been scobed using plastic-encased metal wires horizontally and hazel spars diagonally. The ridge has been netted, extending onto the main roof for a few inches, whilst the rest of the thatch has been left uncovered. There is a thin layer of mossy vegetation growth across the surface of the thatch, which is heavier directly below the ridge and down next to the skewes.

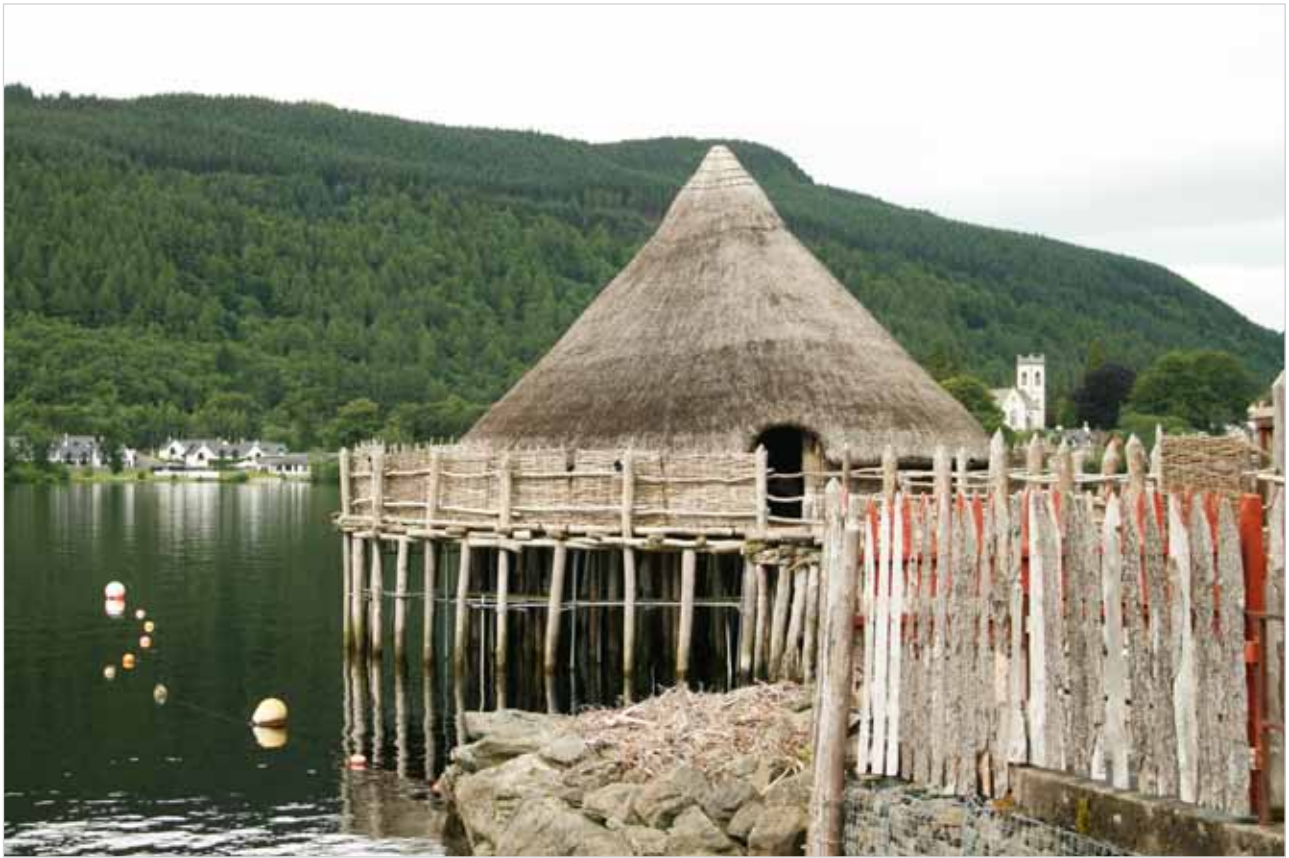
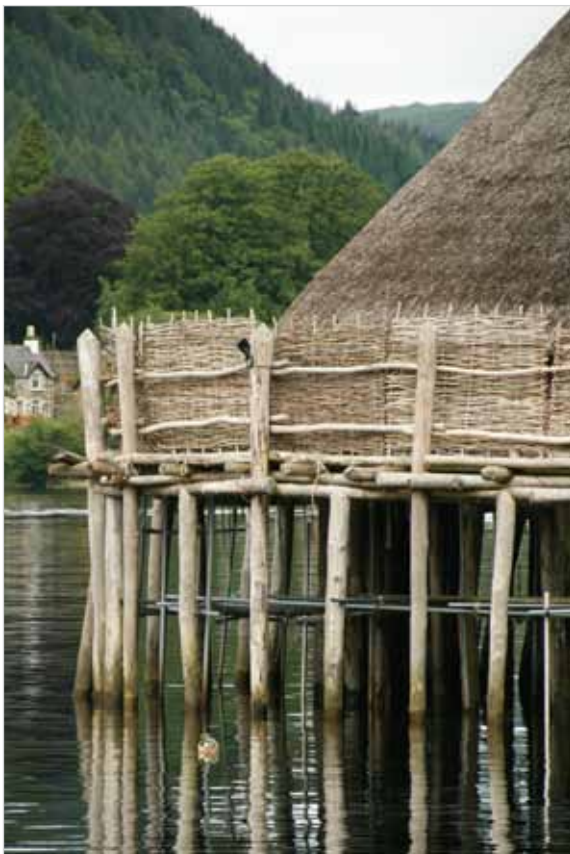
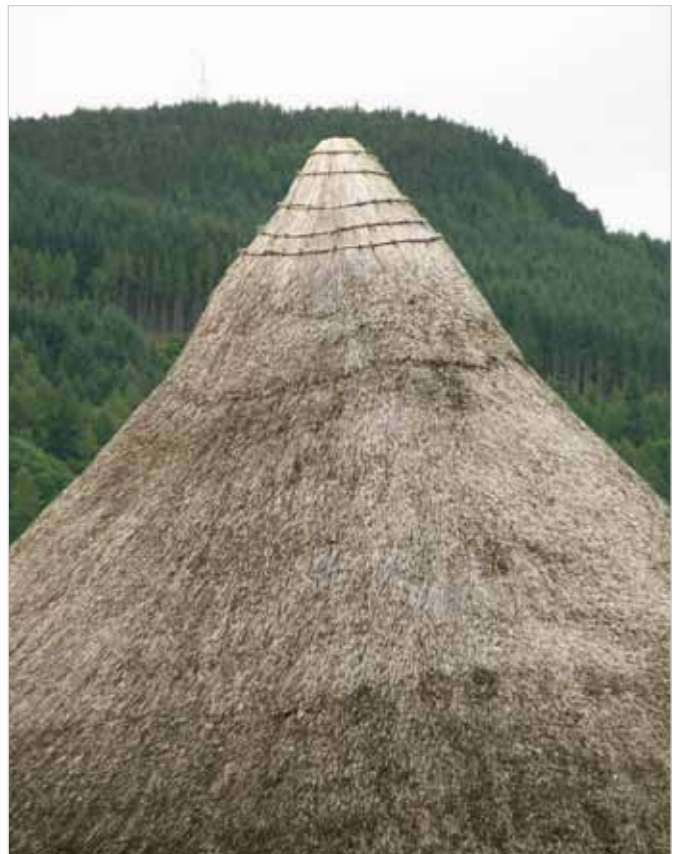
The Scottish Crannog Centre – Perth & Kinross

Condition of Thatch: ..... Good

Additional Notes: ..... Construction on this replica crannog built by the Scottish Trust for Underwater Archaeology, was begun in June 1994 on the waters of Loch Tay and the building opened its doors to the public as part of the Scottish Crannog Centre in July 1997. An excerpt from text on Canmore about the crannog (taken from *Crannogs of Loch Tay*, N Dixon, 2000) states that the building has a reed-thatched roof 'secured by lashings, rather than pegs or pins' and suggests that 'bracken may have been used in antiquity'. The thatch at the apex of the conical roof has been secured with five rings of spars, which appear to be made from hazel. The thatch,

which is a replica of a crannog and uses traditional construction techniques and materials, has been left uncovered. Above the door openings to the south, the thatch has been sculpted along the eaves to allow entry.

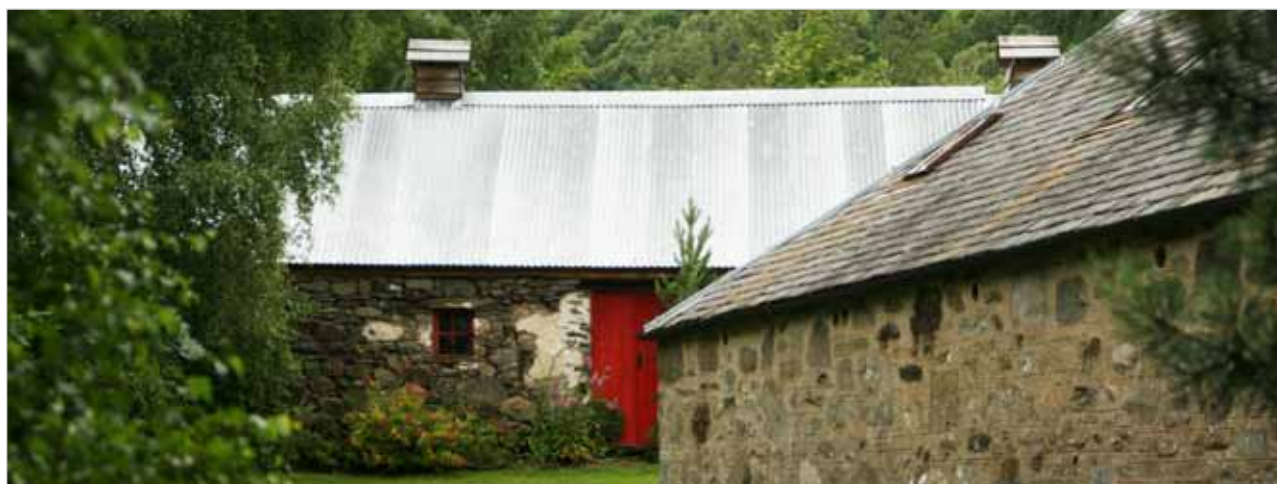
Address: ..... Camserney Longhouse

**Additional Notes:** ..... Mid 18th-century or earlier longhouse, which was restored in 1992 and in 1997. According to the listing description, the thatch was reinstated in 1992 by Duncan Matheson, who installed a roof of 'rye straw and heather divots'. The listing notes also state that the thatch was renewed in 1997. During the renovation work in the 1990s, corrugated iron had been removed from the roof and the thatch was reinstated; however, corrugated iron has been installed again on the roof, presumably covering the thatch underneath. Internal access could not be gained upon visiting and therefore the condition of the thatch could not be determined. Further investigation into the status of the thatch should be undertaken. The grid reference held by Historic Environment Scotland in the listing record and on Canmore (NN 81688 49248) needs to be corrected, as they both identify the adjacent farm buildings to the south.
